**Bernalillo County  
Environmental Health Department**

**Piñon Ridge Subdivision  
On-Site Wastewater Assessment of  
Affects on Groundwater Quality**

**December 2002**

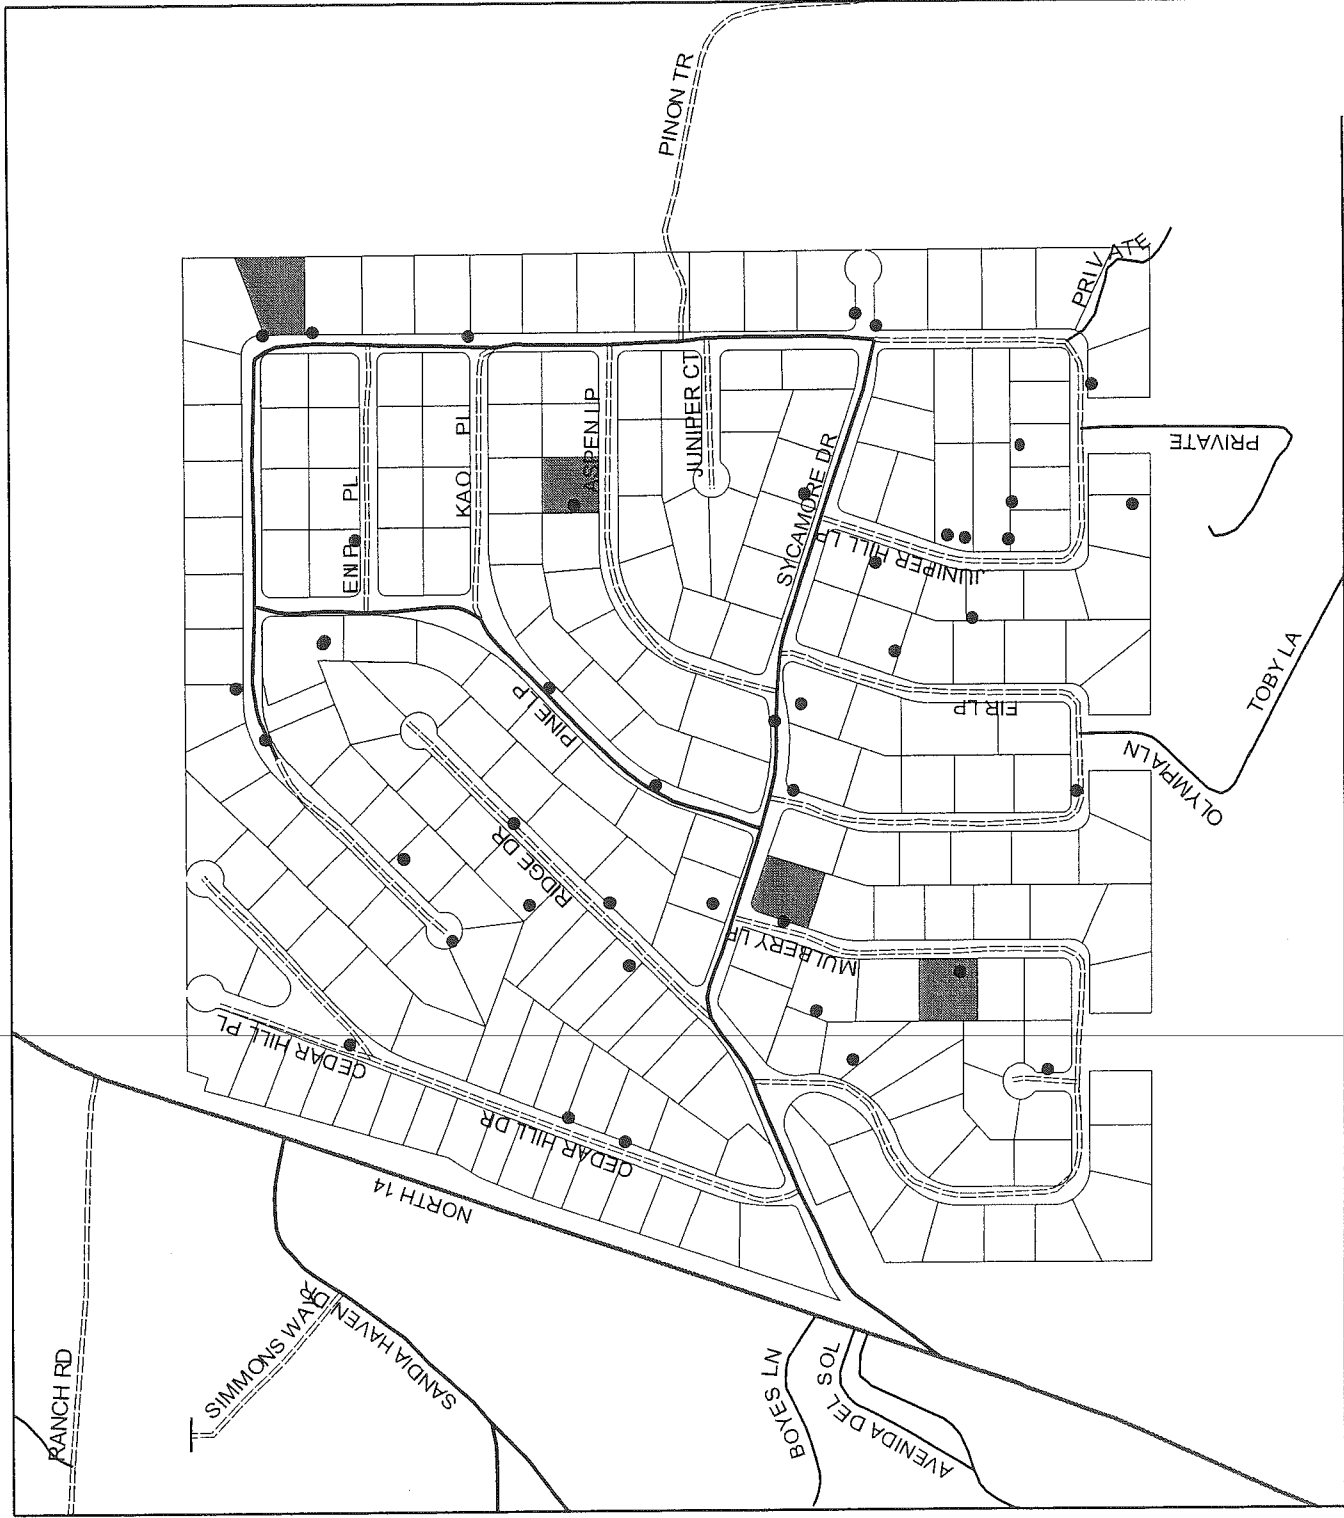
FIGURE 4

# **WATER TYPE 1**

- 46 Mulberry Lp
- 37 Mulberry Lp
- 66 Juniper Hill Lp
- 15 Aspen Lp

Six different water types were identified with the water analysis results of cations and anions plotted on the trilinear diagrams. When a mineral is dissolved in water, the cations and anions of which it is composed will attain a specific concentration. The locations of the six water types are shown on Figures 4 through 9 and on Table 2.

**Water type number one** (Figure 4) is classified as saline. This water is high in sodium, potassium, chloride and sulfate. This water quality was influenced by an aquifer containing shale.

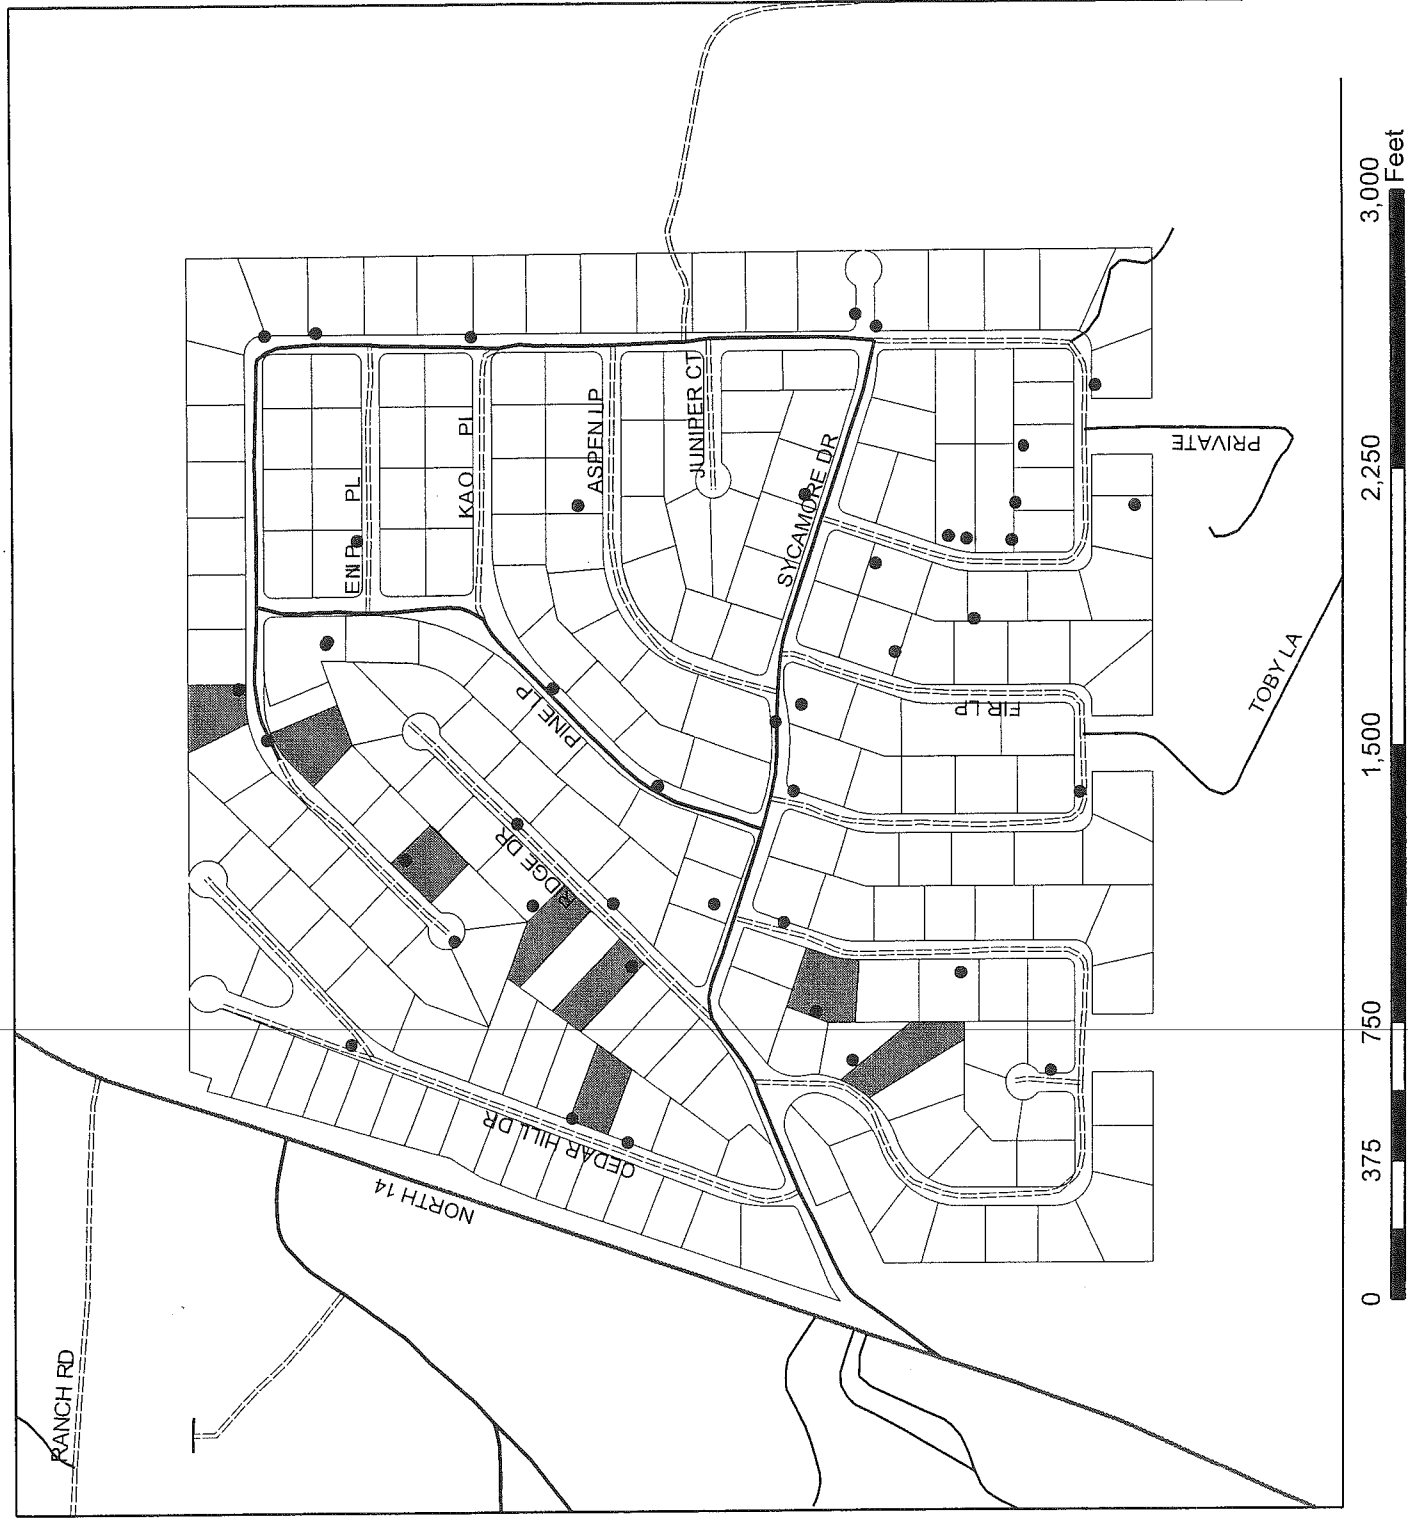
## **WATER TYPE 3**

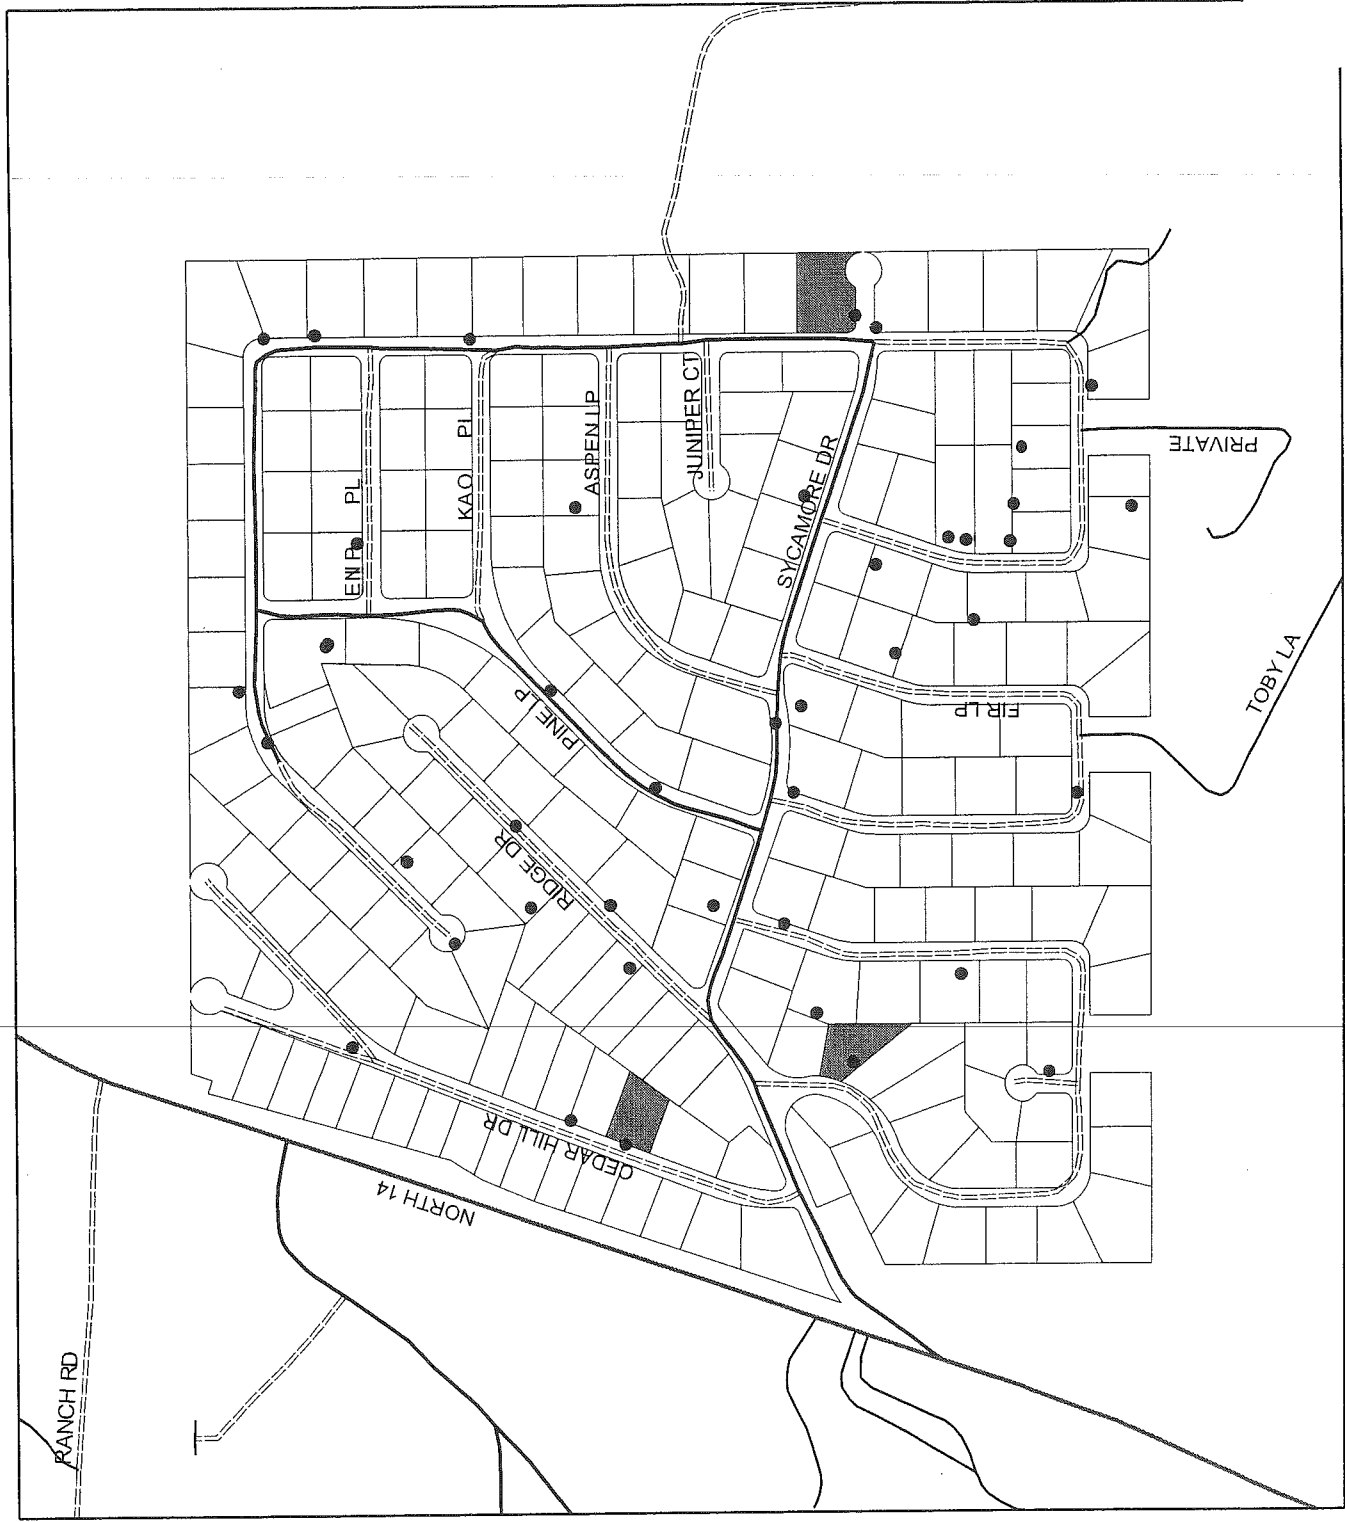
## **WATER TYPE 4**

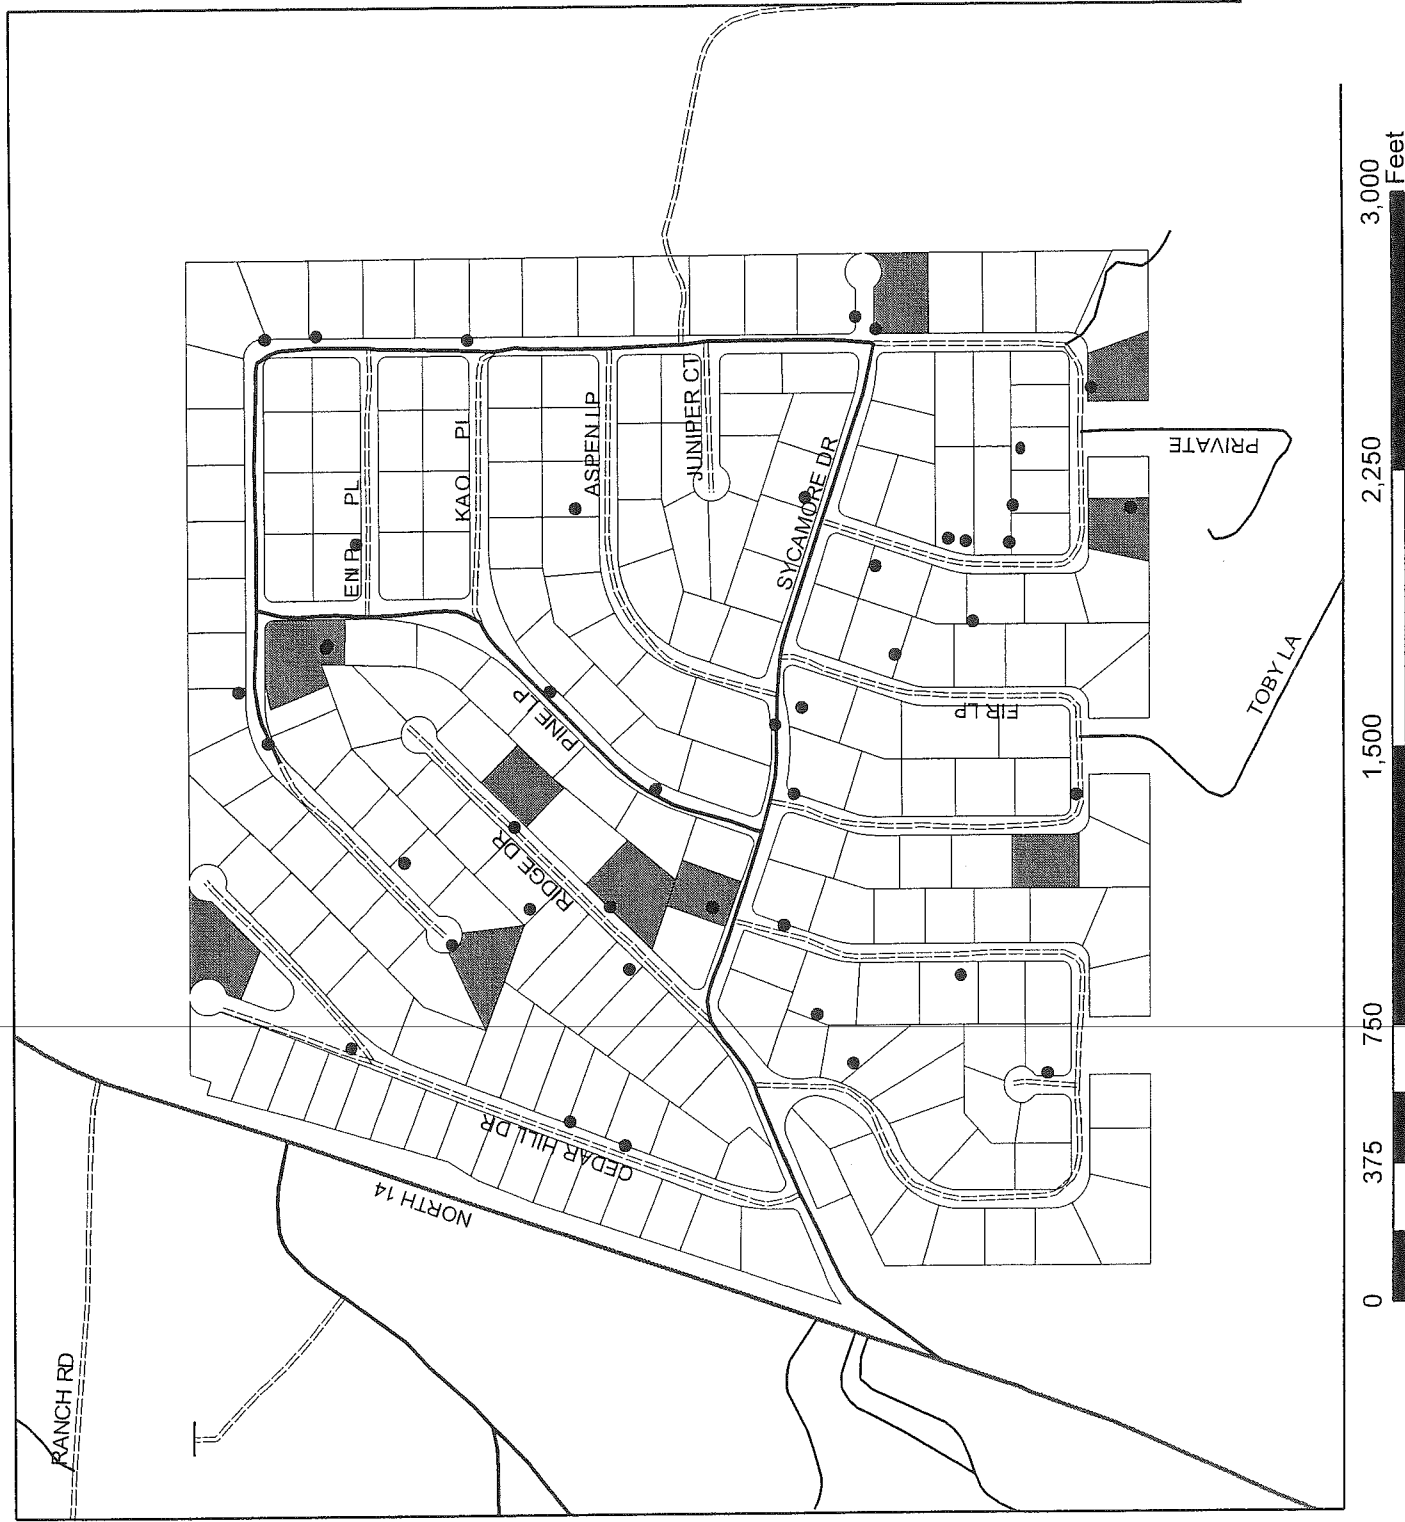
## **WATER TYPE 5**

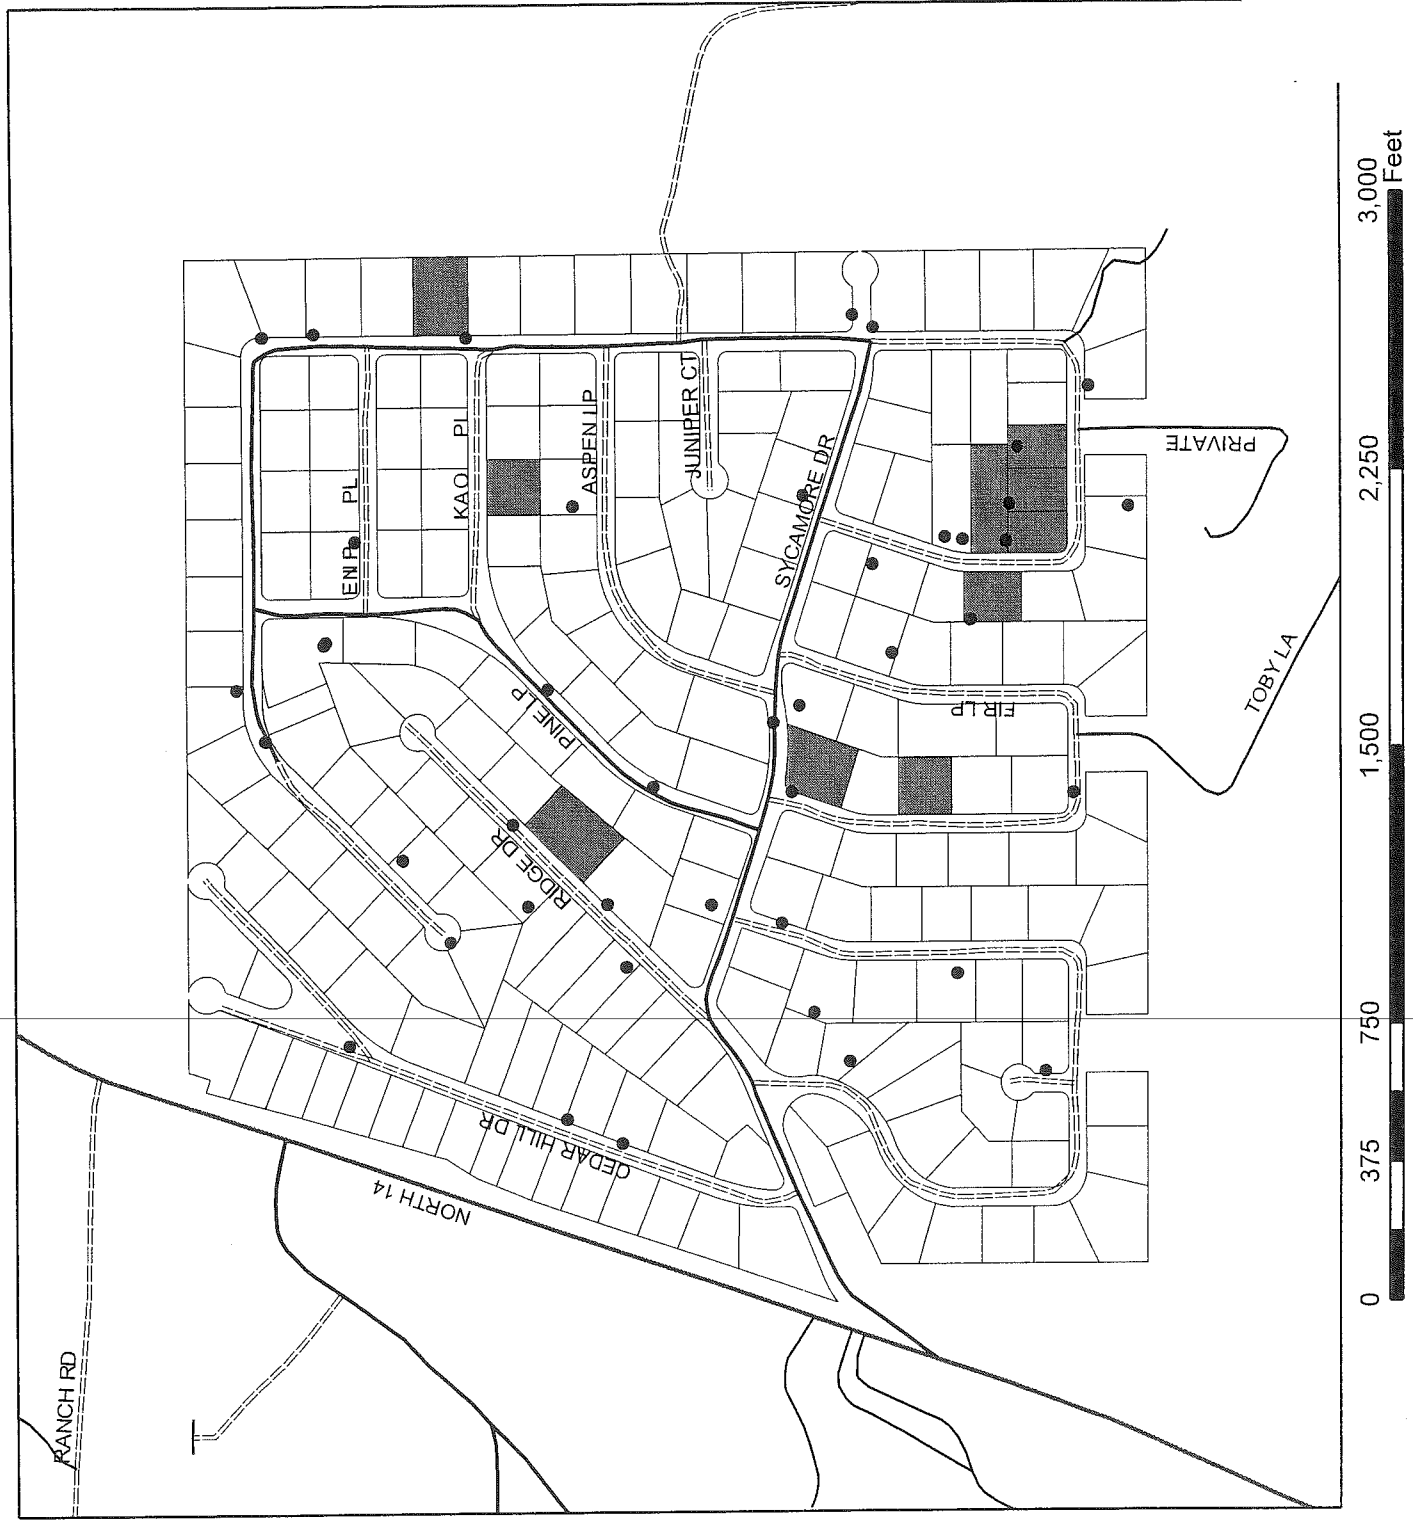
**FIGURE 9**

**Water type number six** (Figure 9) is classified as permanent hardness. This water is high in calcium, magnesium, chloride and sulfate. This water quality was influenced by an aquifer containing gypsum and calcite.

## **WATER TYPE 6**
